MAJESTIC
HOME INSPECTORS

Home Inspection Report

3524 Summer Drive, Friendsville, TN 37737

Saturday, August 20, 2016

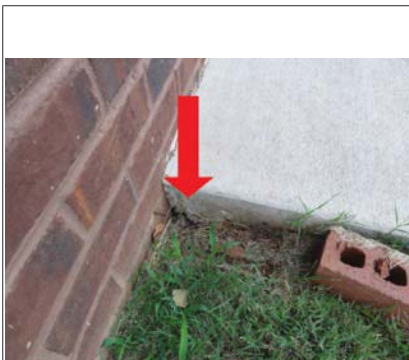
Driveway: left side of driveway at garage has slight hole where water could enter the crawlspace, recommend filling in this hole to channel water away from foundation

Hole

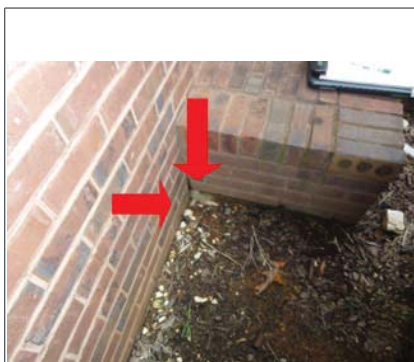
Steps: to the left of the porch steps at foundation in the corner has hole where water is entering crawlspace causing subfloor to rot, recommend filling in this area and adding additional backfill to better channel water away from the home

Hole

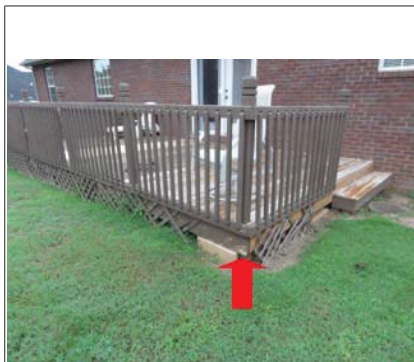
Deck: looking at the deck, the front right corner, the outer support board is starting to rot, recommend repair and replace as needed

Wood rotting

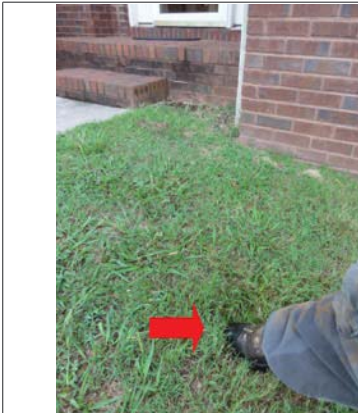
Landscaping: to the right of front porch steps by the gutter has small hole in the yard which could be a fall hazard, recommend filling in this hole

Hole

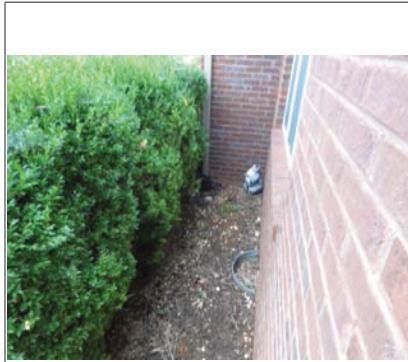
Landscaping: on the left side of front porch slight negative grade toward foundation allowing water to enter subfloor, recommend adding additional backfill to better channel water away from the foundation

Left side of front porch that needs backfill

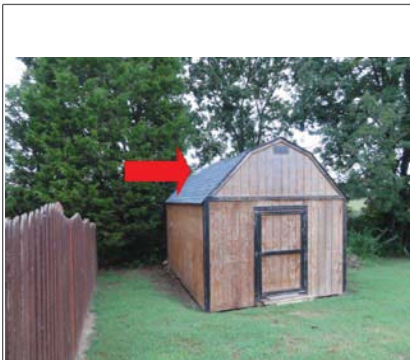
Outbuilding: on the roof back left some shingles need repair, repair as needed

Roof needs repair

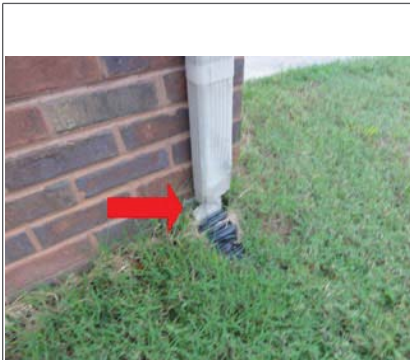
Gutters: gutter to the left of the garage has separated from extension at the bottom, recommend reattaching

Gutter has separated

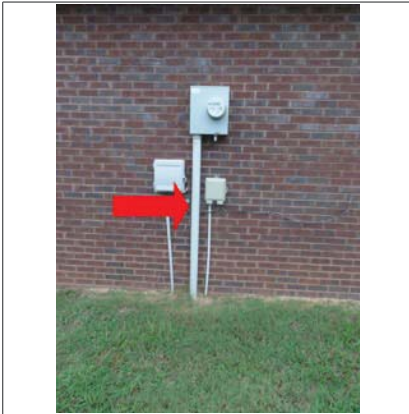
Electrical: meter base PVC service pipe does not have any support straps, recommend licensed electrician to install support straps

No support straps

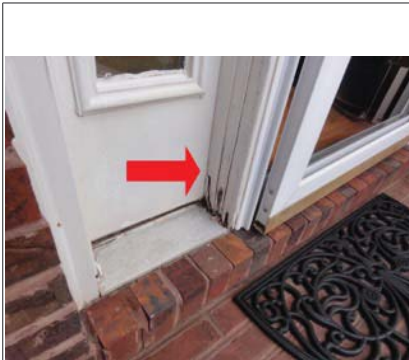
Comments Front door: outside trim at front door bottom left is starting to rot, recommend repair and or repainting around entire front door

Door trim starting to rot

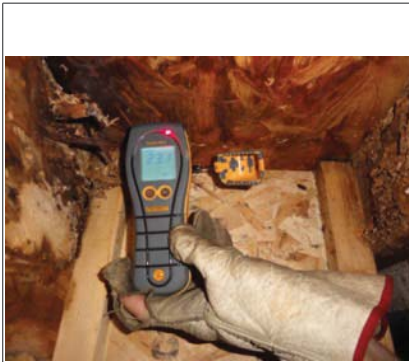
Crawlspace: under neath deck door has moisture content, water staining and can see daylight, recommend removing some deck flooring planks to see the cause of water entering this area

Underneath deck door

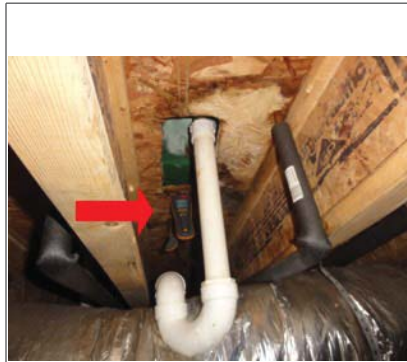
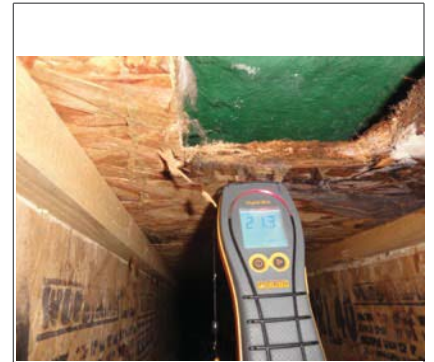
Crawlspace: underneath hall tub has moisture content in subfloor, recommend contacting license plumber to find cause of water entering subfloor

Hall bathroom area

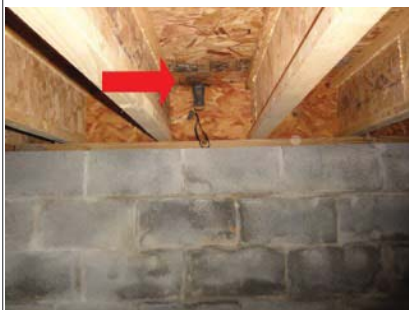
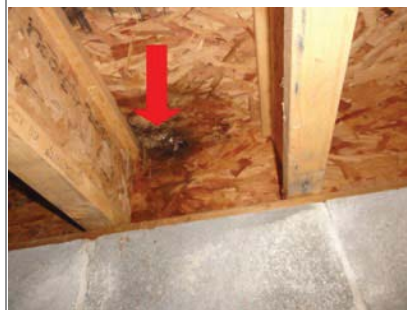
Crawlspace: by front porch on right side the subfloor has moisture content and water staining coming from negative grade left side of porch, recommend adding backfill in this area to better channel water away from the crawlspace

Left of front porch

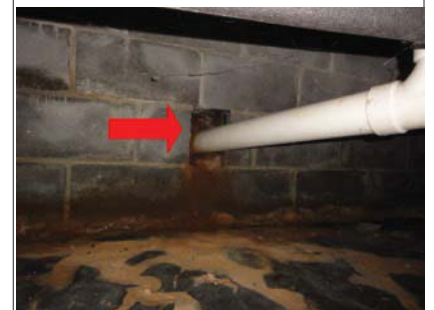
Crawlspace: underneath deck area where main drainage PVC goes out to septic tank concrete block has been cut out and allowing water to enter crawlspace, recommend filling in this area to keep water out

Drain entry PVC

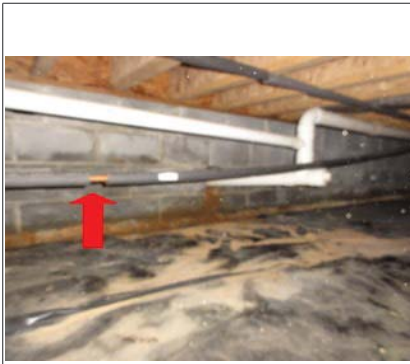
Crawlspace: along backside of house has copper plumbing pipe hanging down with no supports, recommend supporting this copper plumbing pipe

Sagging copper water pipe

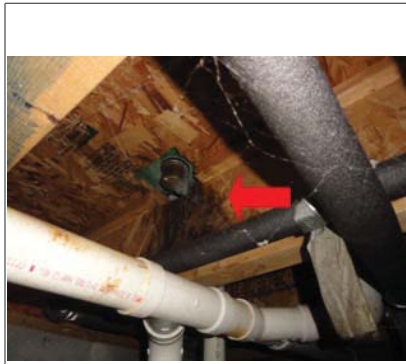
Crawlspace: underneath master bathroom shower tub area shows signs of moisture, recommend licensed plumber to evaluate cause of water staining, shower grout has separated and water could be entering sub floor from that point, recommend re-grouting around tub shower area

Underneath master bathroom

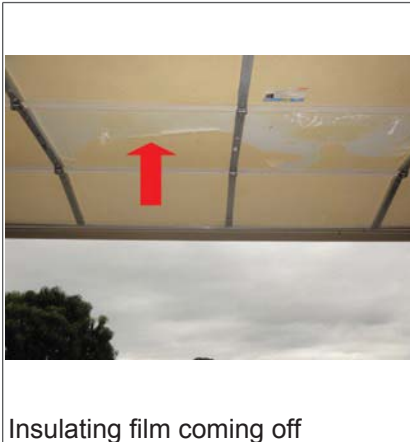
Comments Garage door: back side of the garage insulating film is starting to come off, monitor in repairs needed

Insulating film coming off

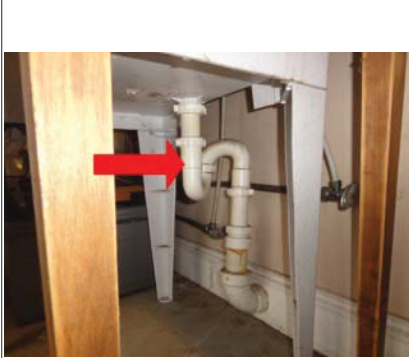
Garage: sink in garage has S-Trap type of drain which could allow water to siphoned out of the trap causing sewer gases to enter the home, recommend installing P-trap type drain

S trap

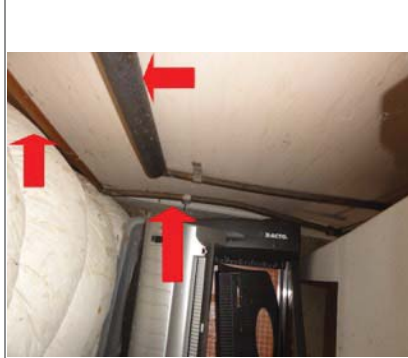
Garage: water lines going to sink from water heater are not supported with straps, recommend supporting copper water lines

Plumbing pipes are not supported

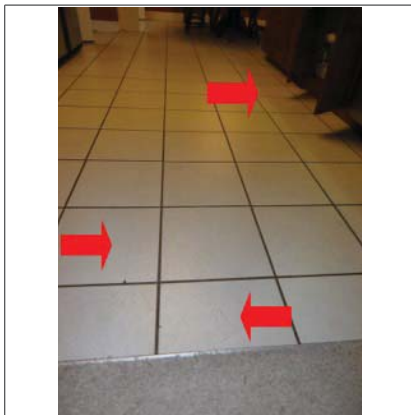
Comments Kitchen: there are various cracks in the kitchen floor tile which could allow water to enter the subfloor, recommend replacing broken tile

Cracks in kitchen floor tile

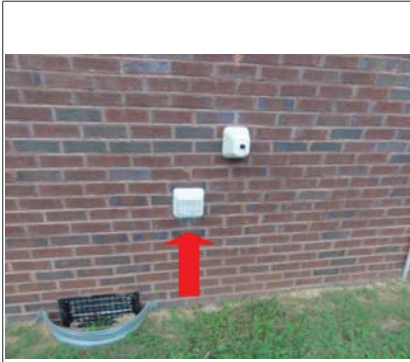
Dryer: outside dryer vent has plastic screen type cover which could collect lent and cause a back up into dryer, safety hazard, recommend removing this plastic type of screen

Dryer vent with screen type cover

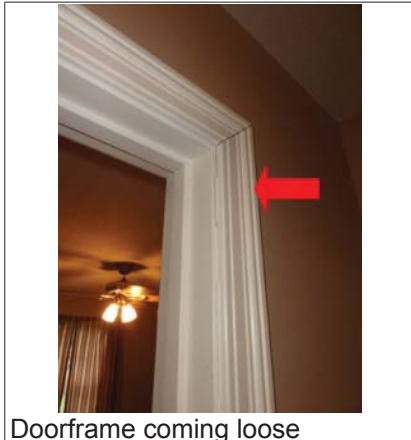
Master bedroom: door frame is pulling off, repair as needed

Doorframe coming loose

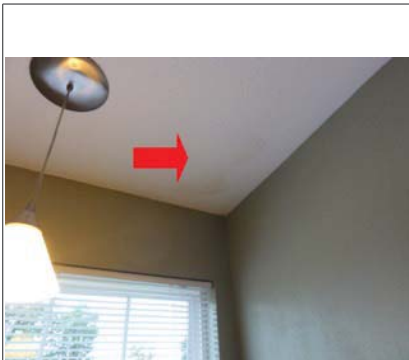
Master bathroom: above hot tub as previous moisture stain on ceiling, currently no moisture content

Previous moisture stain

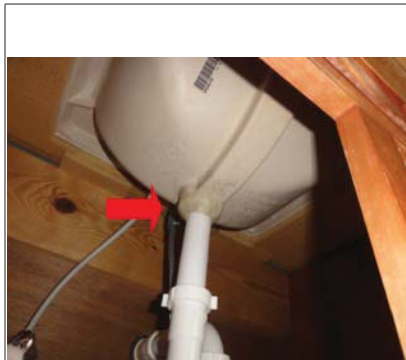
Master bathroom: underneath the vanity at the base of the sink there is a lot of putty where the plumbing washer should be, recommend removing putty and putting proper washer in its place

Wad of putty

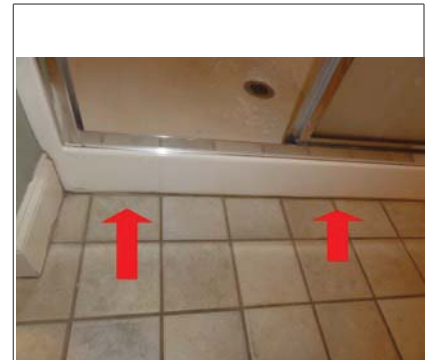
Master bathroom: outside of shower at the bottom grout has cracks and broken which could allow water into subfloor, recommend re-grouting bathroom in various places as needed

Grout missing

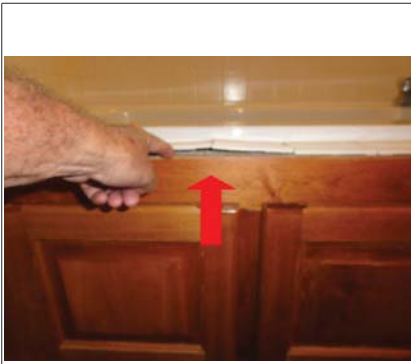
Master bathroom: all around the hot tub various tiles are pulling up, need repair and re-grouted

Tile pulling up

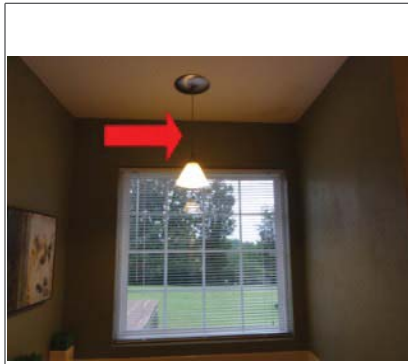
Master bathroom: above hot tub has a light fixture that hangs down and not suited for wet locations, safety hazard, recommend replacing light with a wet location type fixture

Incorrect light fixture for bathroom

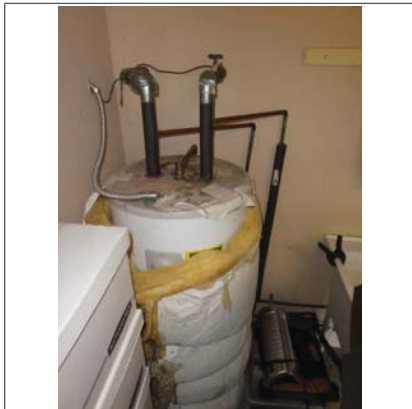
Comments Water heater: water heater is wrapped with insulation, could not see label and entire length of relief valve piping
